**WESTERBEKE**

SERVICE BULLETIN 92

SUBJECT: Troubleshooting Water Temperature and Oil Pressure Gauges

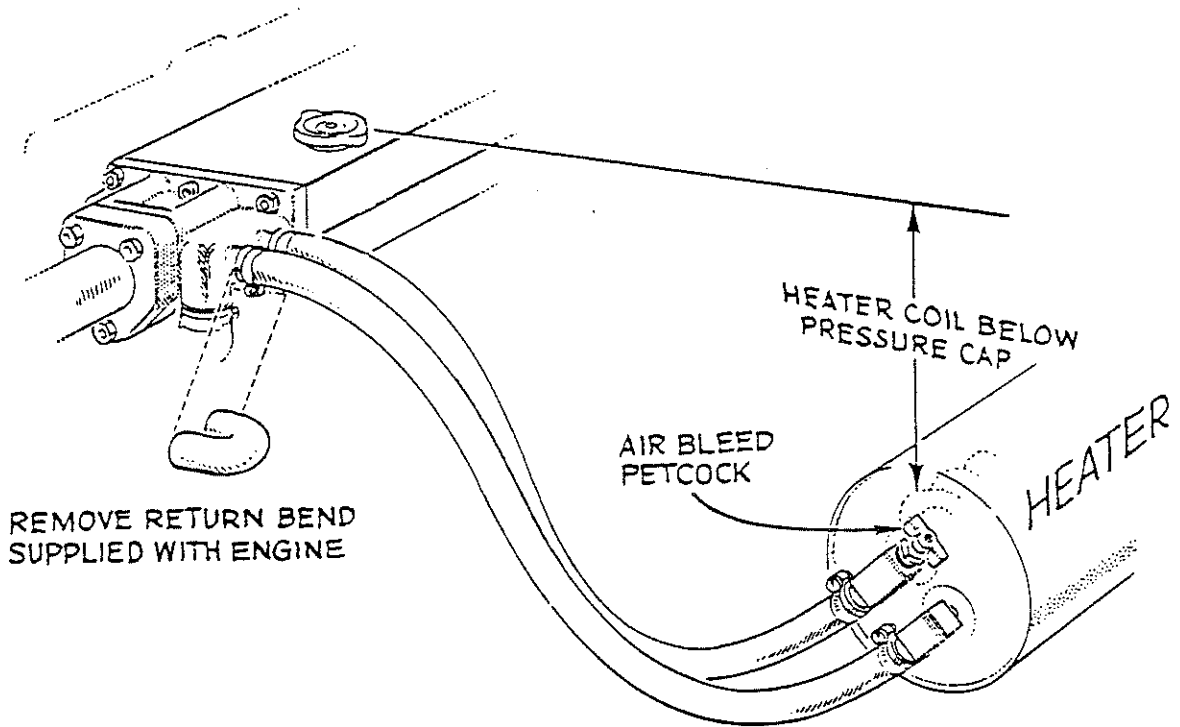
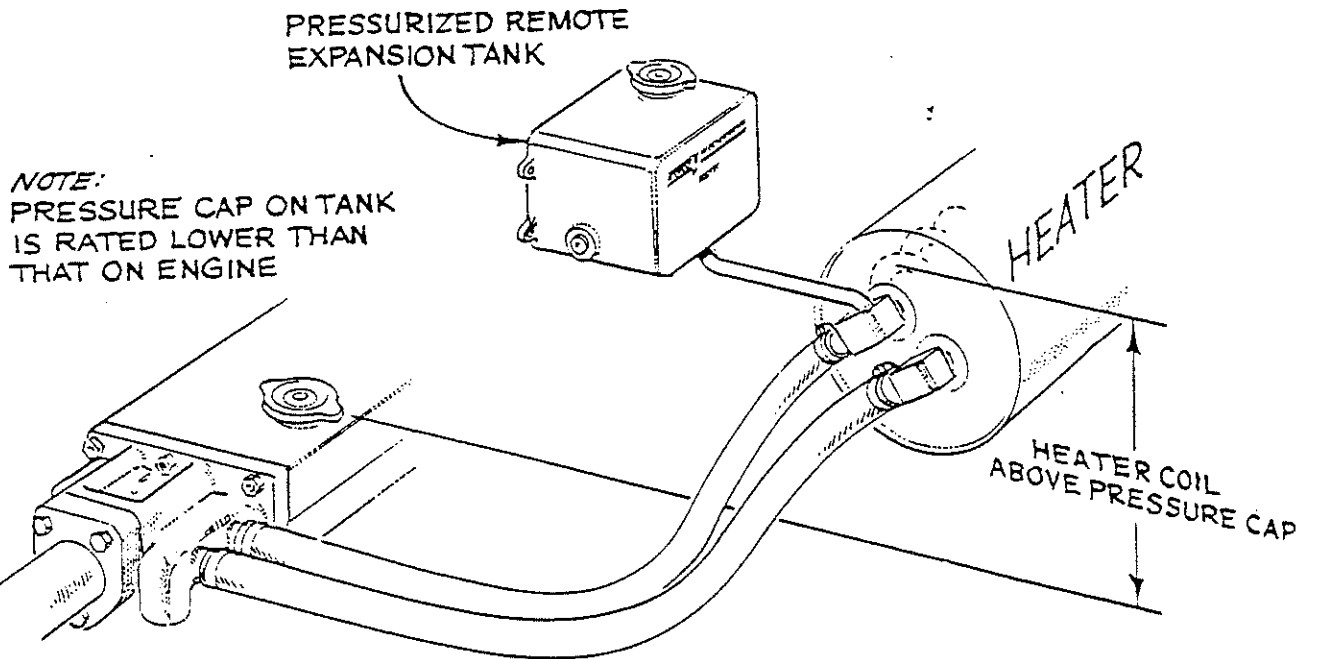
Hoses should rise continuously from their low point at the heater and to the engine so that trapped air will rise naturally from the heater to the engine. If trapped air can rise to the heater, then an air bleed petcock must be installed at the higher fitting at the heater for bleeding the air while filling the system. Avoid loops in hose runs which will trap air.

If any portion of the engine cooling water circuit to or from the heater rises above the engine's own pressure cap, then the pressurized remote expansion tank must be installed in the circuit to be the highest point. The tank kit Part Number is 24177. Install the remote expansion tank in a convenient location such as a sail locker for ease of checking fresh water coolant level.

The hose connection from the heater to the remote expansion tank should be routed and supported so as to rise continuously from the heater to the tank enabling any air in the system to rise.

Installation: Remove the return bend which normally connects the 7/8" hose spuds on engines as shipped from the factory. Connect these spuds to the heater with 7/8" ID wire inserted hose. The spud marked "out" indicates the flow from the engine and the spud marked "in" indicates the flow returning to the engine.

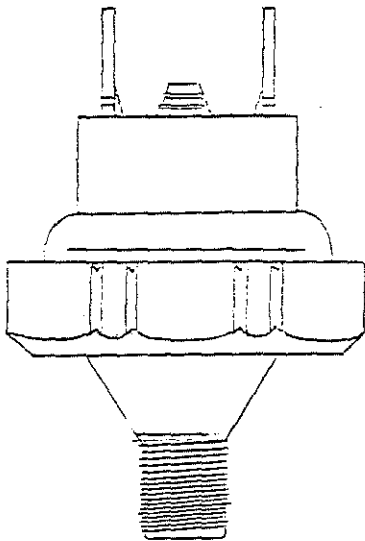
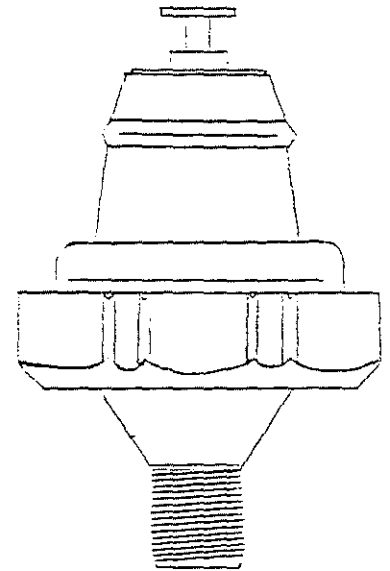
## ILLUSTRATION

The correct socket can be acquired through well-known tool manufacturers such as Snap-On, New Britain, Cromwell, Proto and others. The use of channel lock pliers, vise-grips or pipe wrenches, is not advised, in that they may cause damage to the seal between the metal body and the plastic center insert, resulting in a leak and/or switch failure.

When removing and installing oil pressure switches of the type illustrated below, care should be taken to use the correct type socket specifically designed to correctly fit the metal circumference of these switches.

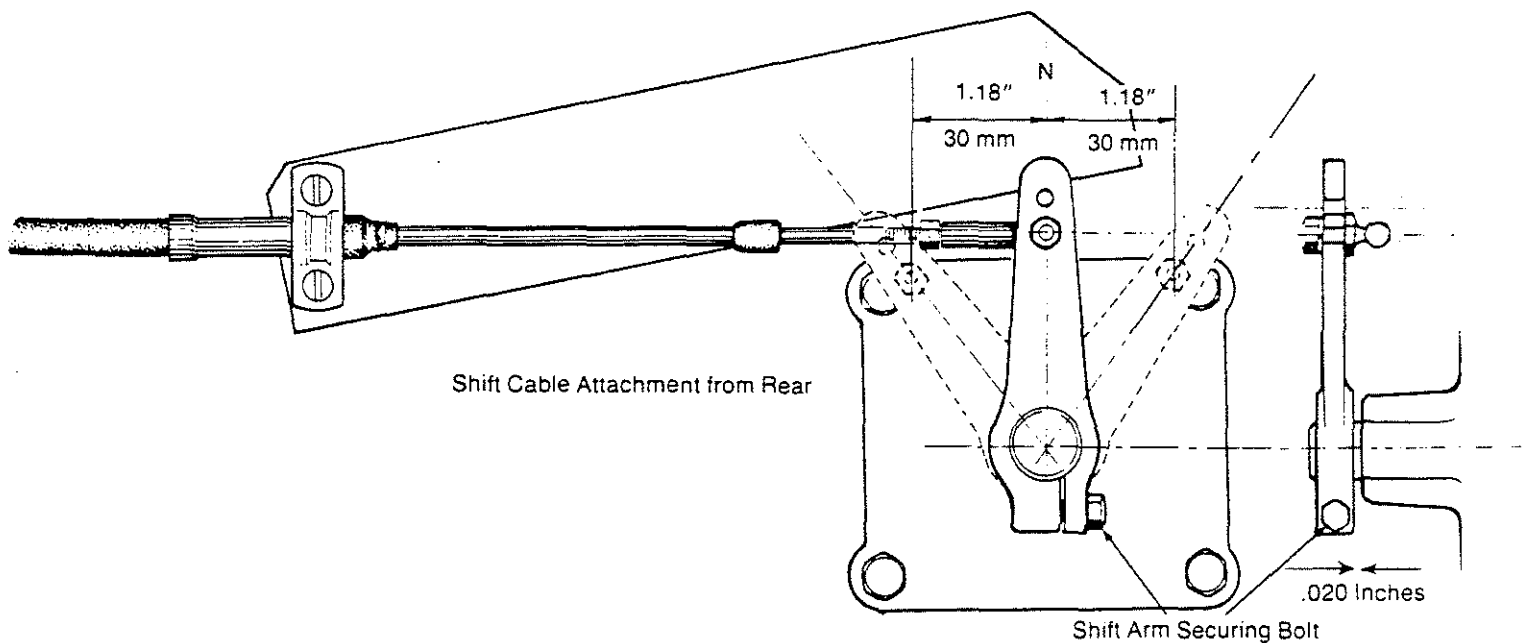
Minimum Travel (inner hole used)

Failure to properly adjust the shift arm and cable to produce the MINIMUM shift arm travel required for clutch engagement will result in clutch slippage and eventual failure.

The control cable, when attached to the transmission shift arm ball joint connector, should be attached so as to be at a 90° angle with the lever and transmission in the neutral position (Ref. Illustration).

The transmission shift arm can be rotated on the transmission side cover shifting shaft by loosening the securing bolt (13mm) and rotating the shift arm to produce the 90° angle between the arm and the shift cable when the transmission is in neutral. Insure that there is at least .020 inch clearance between the shift arm and the shift cover before retightening the securing bolt.

The shift cable and pedestal control must allow the transmission shift arm to move from the neutral position into the forward or reverse engagement a MINIMUM of 1.37 inches (35mm) when the outermost ball joint attachment hole is used on the shift arm, or 1.18 inches (30mm) when the inner is used. Use of the inner attachment hole is preferred (Ref. Illustration).

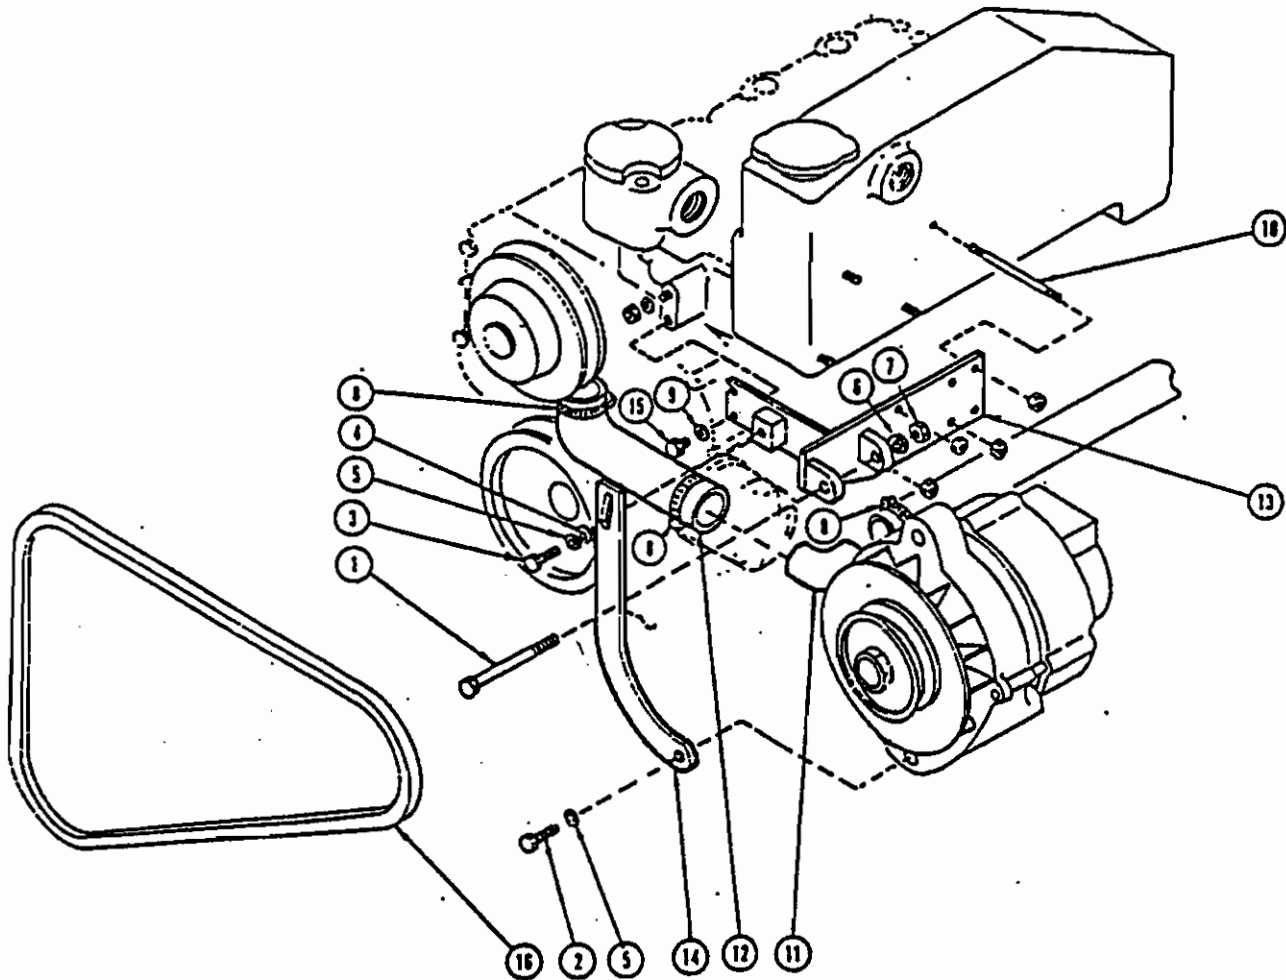
Alternator Mounting Kit #256891 Components

Westerbeke Corporation has become aware that some early model Universal M18, M25 and M25XP marine engines having the DC charging alternator mounted directly to the front gear case cover have experienced failure of the gear case cover at this mounting point.

Owners of these early Universal models are encouraged to inspect their units and if they find the DC charging alternator mounted directly to the front gear case cover that they purchase a conversion kit PN# 256891 that will allow for the mounting of the alternator on a bracket that is attached to the engine's exhaust manifold as later model engines were configured to. The illustration with this bulletin lists the kit components and shows their location on the engine.

Contact your local area Westerbeke/Universal dealer to order the alternator mount conversion kit #256891 and front gear case cover parts as needed.

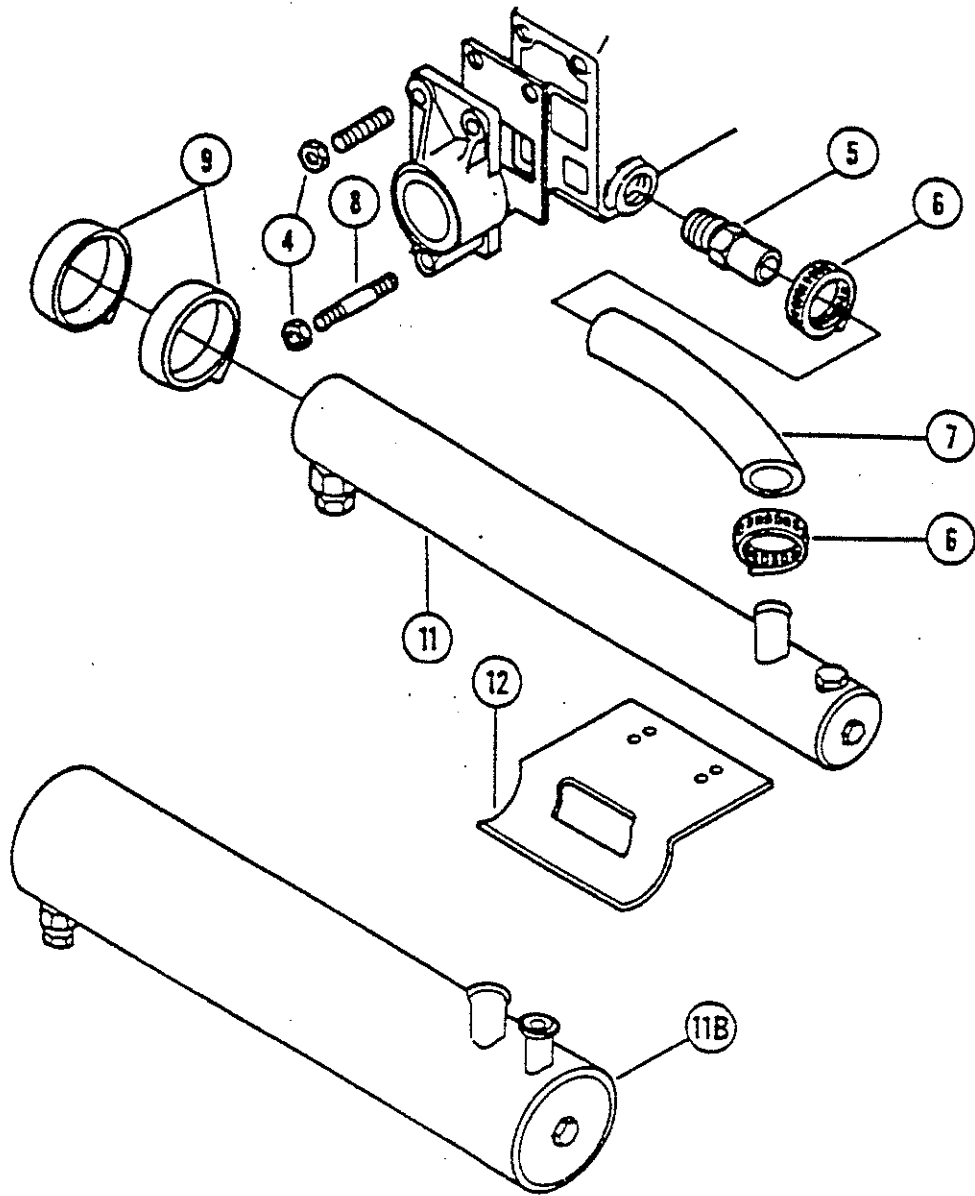
## Heat Exchanger Group - New Style

These complaints are possibly related to the heat exchanger size used on these early models. One should keep in mind that there are other components and areas of the engine's cooling system that could cause or contribute to high operating temperatures and overheating. These are:

If these areas 1-6 have been inspected and any faults that are found are corrected and overheating still occurs, it is recommended that the operator consider replacing the two inch diameter heat exchanger (P/N #299049) originally supplied with the engine with the three inch diameter heat exchanger Universal incorporated on later models (P/N #299835).

The illustration shows this larger heat exchanger, reference #11B. The contoured mounting bracket reference #12 will have to be reworked to fit the contour of the larger exchanger. This can easily be done by removing the bracket and using a piece of three inch iron pipe as a template to rework the bracket to the proper contour. Use two cushions #033487 between the exchanger body and the bracket along with heavy duty clamps (P/N #303070) when mounting the heat exchanger to the reworked bracket. The illustration helps show these components.

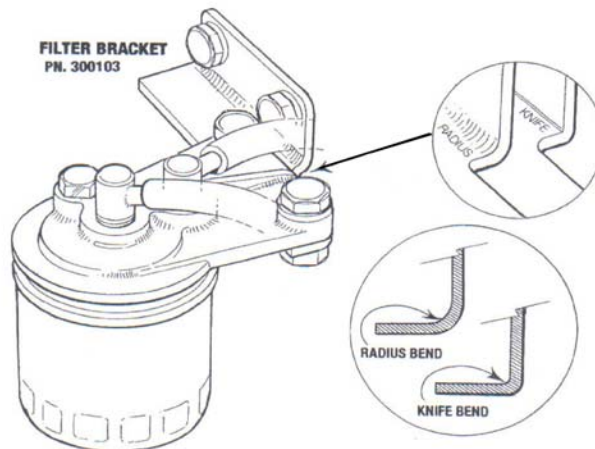
DETAIL: FRACTURES HAVE BEEN REPORTED FROM THE FIELD IN THE AREA OF THE 90-DEGREE BEND

THIS KNIFE EDGE BENDING PROCESS PLACES A NOTICEABLE CREASE ALONG THE BEND WHICH CAN STRESS THIS AREA OF THE METAL CREATING THE POSSIBILITY OF A FRACTURE TAKING PLACE ALONG THIS CREASE.

NOTE: TO LOW OF AN ENGINE IDLE SPEED WILL PRODUCE FILTER VIBRATIONS THAT CAN AFFECT THE FILTER BRACKET AND LED TO ITS FRACTURING AT THE 90 DEGREE BEND.

THE ABOVE SUBJECT MODELS USING THIS BRACKET MANUFACTURED PRIOR TO SEPTEMBER 2004 (E409) ARE SUSPECT. VISUALLY INSPECT THE BRACKET AND IF A CREASE IS VISIBLE ALONG THE BEND AREA. CONTACT WESTERBEKE CORPORATION AT 508-823-7677. PROVIDE THE ENGINE MODEL AND SERIAL NUMBER AND A SHIPPING ADDRESS AND A REPLACEMENT BRACKET WILL BE SENT AT NO CHARGE.
