**WESTERBEKE**

SERVICE BULLETIN 92

SUBJECT: Troubleshooting Water Temperature and Oil Pressure Gauges

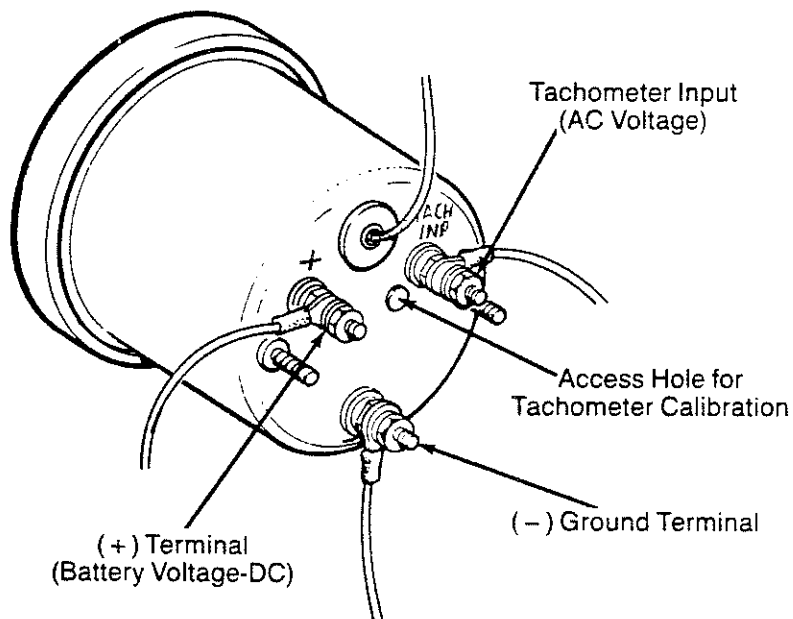
LATE MODEL TACHOMETER

Replaces Earlier Model as Shown on Page 2 of this Bulletin

1. With hand-held tach on front crankshaft pulley retaining nut or strobe type tach read front crank shaft pulley R.P.M. Set engine R.P.M. with hand or strobe tach at 1500-1800 R.P.M.
2. Adjust tachometer with small Phillips type screwdriver through calibration access hole in rear of tachometer covered with translucent plug. Zero tach and bring to R.P.M. set by strobe or hand tach. (Verify R.P.M. at idle and at high speed 2500-3000 R.P.M.) (Adjust tach as needed.)
