1987 MK 1 Catalina 34 Electrical System Upgrade

By Jon Windt; s/v Della Jean

REVISION A – 7-31-2016 Section 11 was revised due to re-routing of the #1, 5, and 14 1 AWG cables directly to the engine compartment from the house bank. The Cable Planner Excel and pdf files, and the pdf file of this write up have been updated and attached to this write up to reflect the current routing. The schematic and cable ID #'s are unchanged, only the routing is different.

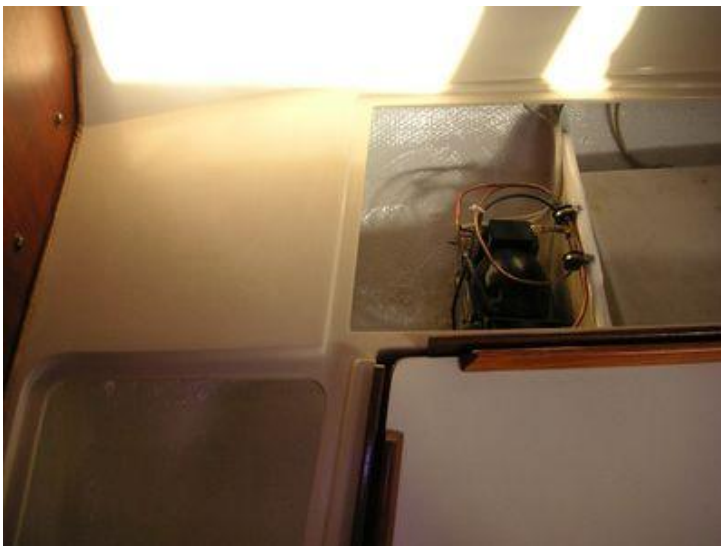
Photos (8) and (9) show the salon area with the wood covers removed. In Photo (8) you can see the fridge compressor attached to the bulkhead at the end of the starboard water tank. Photo (9) shows the water tank and ProMariner ProSport 20A AC charger. The wire from the breaker to the charger had a 3 prong plug connection (like an extension cord) at the charger, and the charger wasn't fastened to anything, just lying there on the hull waiting to flop around. Not very robust.

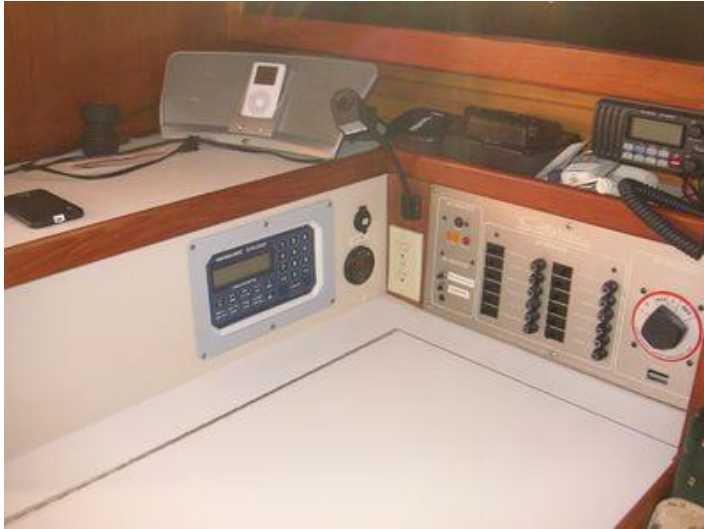
Photo (11) shows the Navigation Station with the OEM Main Panel, Link 10 battery monitor and 12VDC outlet installed by a PO. The panel has a single pole main, the polarity lights flickered, the lens for a light and the light under the battery switch were missing, the Link 10 did not operate.

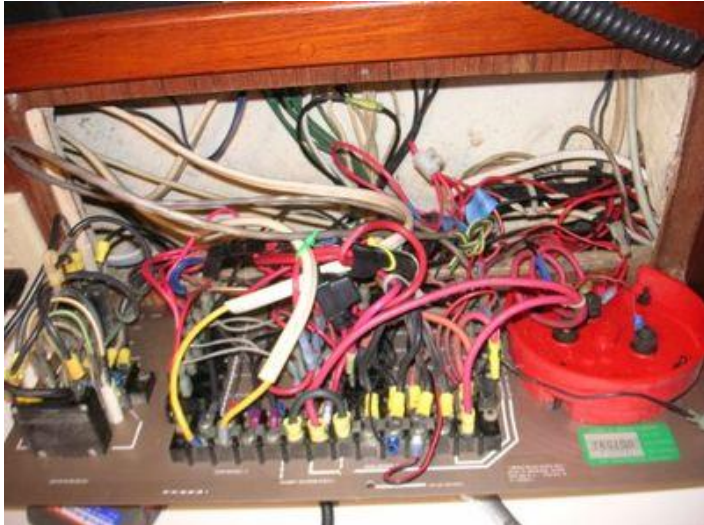
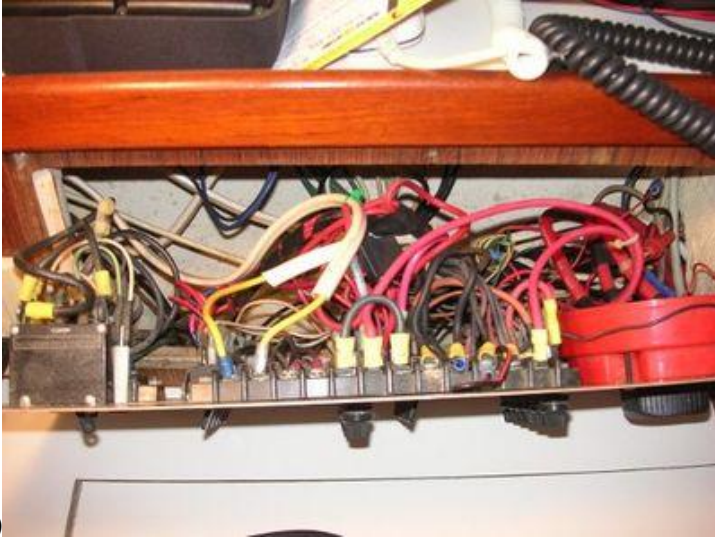
Photos (12) and (13) show the wires behind the main panel. To be polite, it was a corroded mess.

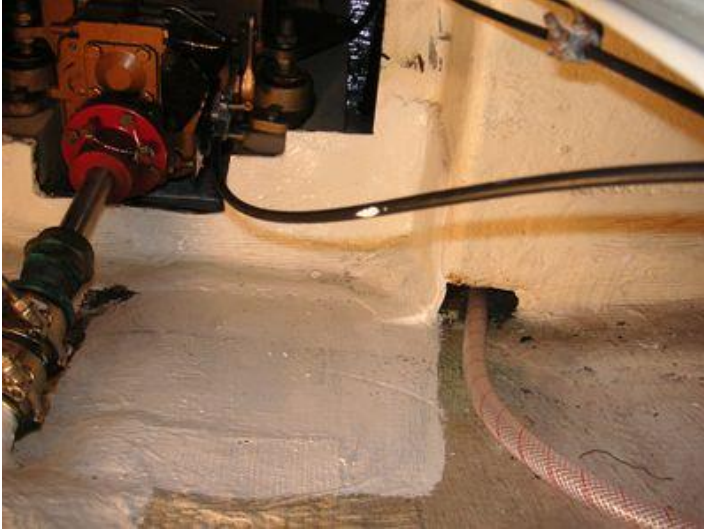
Photos (14) and (15) are taken under the aft cabin with the cushions and wood cover removed. My original plan was to run the cables from the battery compartment under the cabin floor and engine compartment through a hole in this area. (I recently painted this area with white bilgekote when I replaced all the fresh water and vent hoses). In photo (14), you can see 2 small pilot holes I drilled under the port engine mount. I drilled the pilot holes about 1" deep but did not break through. So I plugged the pilot holes with hardwood dowels and 3M 5200 and changed plans. My fall back plan was to run the cables through the opening shown in Photo (15) where the water hose from the aft tank went under the cabin floor to the sink area.

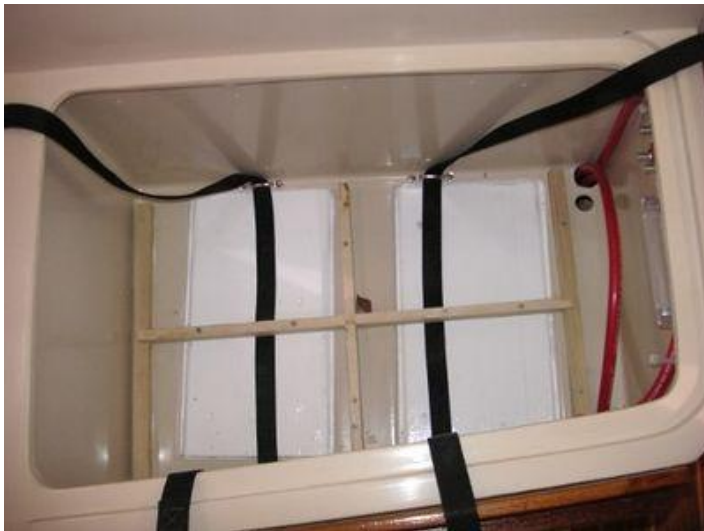
Photos (17) and (18) show the 2x8 painted wood fillers, the “egg crate” made from $\frac{3}{4}$ ” x $\frac{3}{4}$ ” hardwood strips screwed and countersunk to the bottom, and the battery straps all to keep the batteries in place while underway. Photo (18) shows 2 existing holes in the bottom of the box with new cables passing through. (I was later glad to have 2 entry holes). I drilled holes for #8 screws for wire ties along the upper battery box wall, and 2 thru holes for #8 screws in the radius at the bottom of the box on the water heater side. These are to attach wire ties outside of the box near the water heater for the cables that will run in that area. The 2 thru holes were covered with the same silicone caulk used earlier to seal them from a possible battery leak. Be sure the screws do not extend into the battery box or you’ll damage the batteries.

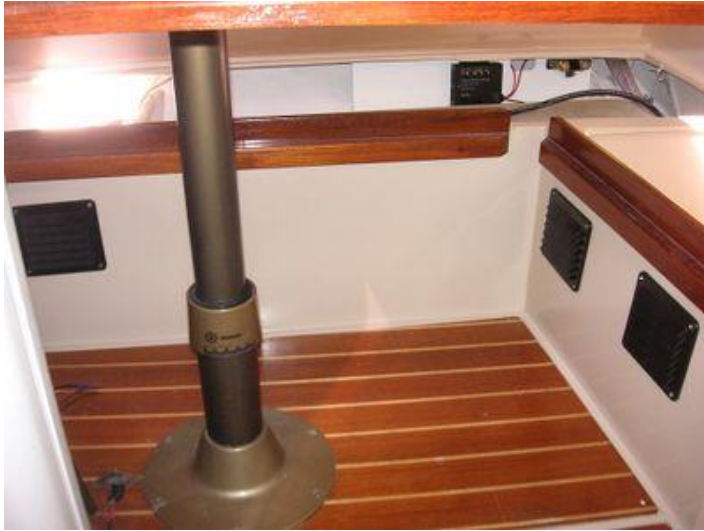
Photos (20 and (21) show the 2 new black ventilation covers installed in the battery box and the 1-2-Both battery switch installed where the bilge pump auto/on/off switch used to be. (In the background of photos you can see the breadboard for the Xantrex Digital Echo charge, house negative busbar, and BMV-700 shunt, but more on that later). The battery switch is a Blue Sea 6007 installed with the front panel mounted option. I used a 2 5/8" Milwaukee Dozer hole saw to drill the hole for the battery switch. It was tricky since I was using the hole saw to enlarge the existing smaller bilge switch hole. The battery box is two walls that are hollow in between. I wedged a piece of wood into the hollow section to give the hole saw pilot bit something to grab on to. I lined up the hole saw with the top of the existing bilge switch hole and went for it. It worked, but maybe not the safest couple of minutes I spent on this project.

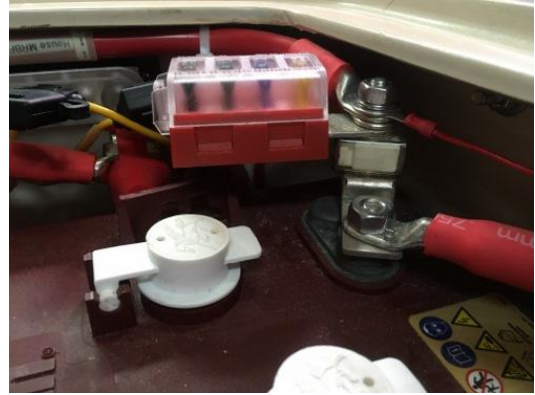
Photos (23), and (23A) show the Blue Sea 5024 fuse block I used to combine 4 fused runs into one small space with one connection point directly on the battery. The battery posts are short allowing connection of only 2 lugs comfortably. Photo (23A) shows the stack sequence on the battery terminal as the Blue Sea terminal block 5191, positive cable #7, then the nut. On the Blue Sea terminal block 5191, the stack sequence is 250A MRBF, Blue Sea 5024 fuse block, positive cable #2, positive cable #1, then the nut. (The cable #'s are shown in the schematic included with this write-up). Many devices require connecting directly to the battery or as close as possible for best results, and is preferred by ABYC code. This does that neatly.

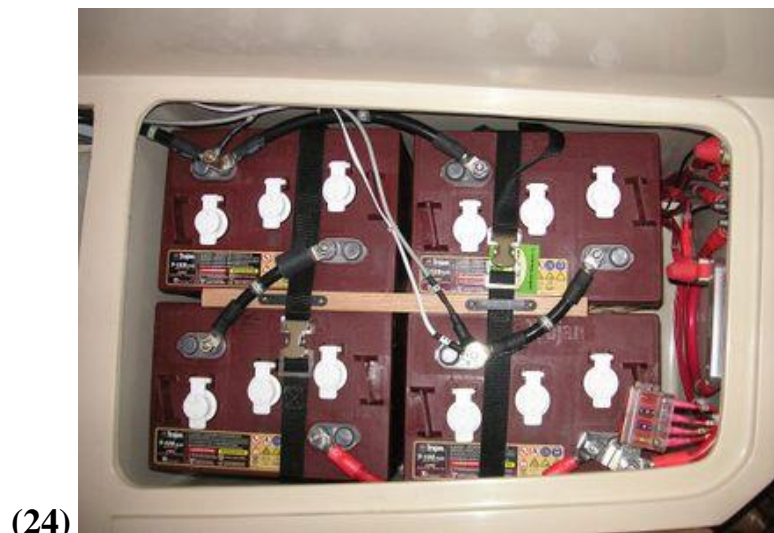
Photo (24) shows the Trojan T105's installed waiting for inspection. I cut a piece of red oak into a "T" shape to fit between the batteries to avoid them tipping together when the battery strap is tightened. The black plastic clips came with the NAPA battery box for the reserve battery. I'm using a higher quality battery strap and stainless steel clips to hold the reserve battery to the shelf, so I decided to use the plastic clips here to keep the wood from sliding. The house bank connects to position 1 on the 1-2-Both battery selector switch. In photo (24), the schematic battery ID #'s starting from the bottom right are #1, bottom left is #2, upper right is #3, and upper left is #4. See the schematic attached in Section 14 of this write-up for the details.

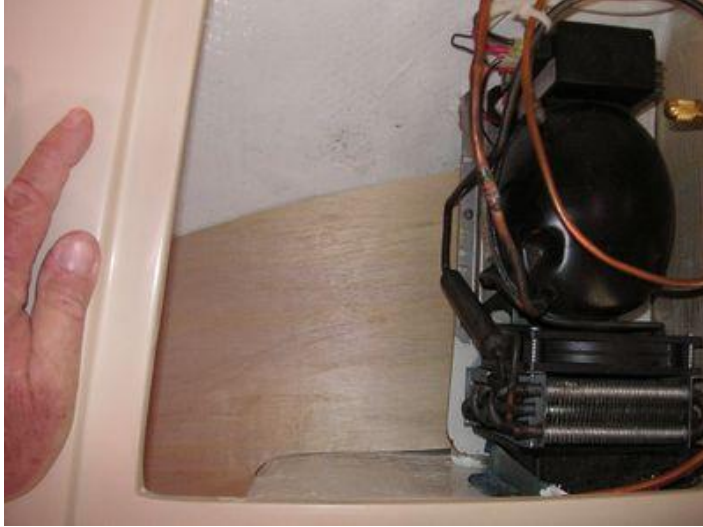
The most common location others install a reserve/start battery on a C34 is under the aft cabin. When I looked at under aft cabin installations, although done well, it was cramped, dark, wet, and hard to service. I chose to add a shelf under the forward outboard starboard corner section of the salon shown in work in photo (25). A loss of storage area, but my storage is limited here due to the refrigerator compressor anyway which you can see in phot (26). Using ½" birch plywood I fabricated a shelf to match the hull, bulkheads, and refrigerator compressor shelf. I cut an opening in the vertical leg of the new shelf for water drainage and access. The underside was painted in the non-bonding areas with white bilgekote before final installation. The hull and bulkheads were sanded for good adhesion, I then used 3M 5200 to bond the shelf to the hull and countersunk screws to bond the top and vertical leg of the shelf together. The screws were covered with a ½" cove molding for looks and a little additional ledge surface to help when removing the battery. The reserve battery was used as a weight to apply pressure while the 3M 5200 cured. The exterior is finished with white bilgekote.

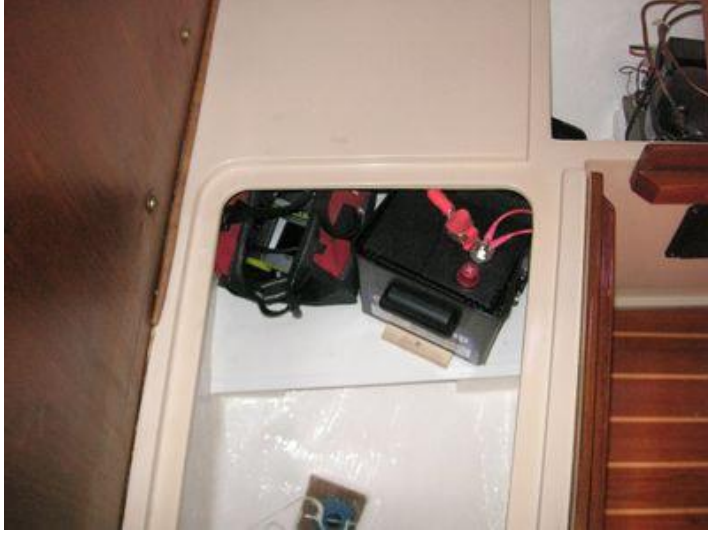
I added hardwood strips, and the same type battery strap as the house bank to keep the battery box from moving while underway. The terminal posts and all fuses are shown in photo (27) are easily accessible by removing a cushion and the wood cover. The SmartGauge and Digital Echo charge in-line fuses are shown mounted on the bulkhead. I also have space to stow a small tool bag as shown in photo (28).

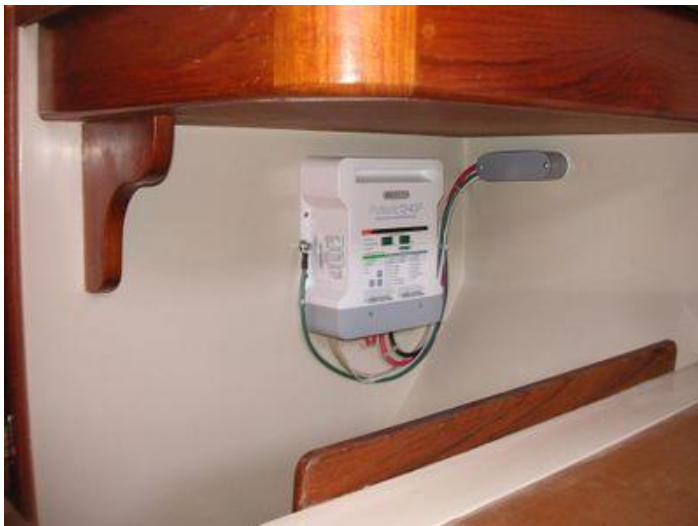
I removed the original ProMariner ProSport 20A AC battery charger that was lying on the hull **unattached** to anything, and replaced it with a ProNautic 40A multistage smart charger. The ProNautic uses battery temperature sensing, and can be programmed for several battery types and profiles for safe and efficient charging. I installed it with 4 screws on the common hanging locker bulkhead underneath the Navigation Station desk, see photos (42) and (43). This allows vertical mounting with plenty of ventilation in a relatively cool dry area. The location does not interfere with my knees when sitting at the desk, but is close enough to get at and change programming if needed. The AC charger wires run through the outboard bulkhead through a conduit LB under the Navigation Station desk. This reduces wires running in the hanging *wet* locker, provides a shorter run to the back of the Main Distribution Panel which is directly above it, and the conduit LB hides the hole.

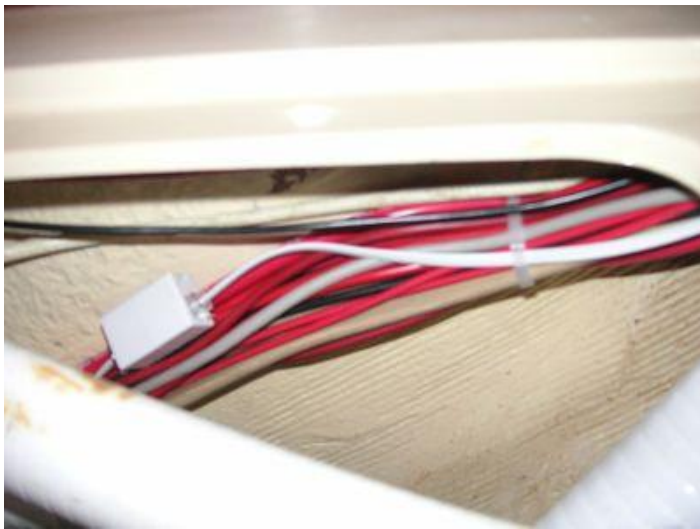
Unfortunately the temperature sense wire provided with the charger is only 10 feet long and will not reach the house bank from here. To solve this, ProMariner suggested using an RJ6 phone coupler and an RJ6 telephone line the length needed. Photo (44) shows the RJ6 phone coupler and the added 12 foot RJ6 wire tied to the main wire bundle just before the macerator pump/motor. Not sure yet if I'll plug the open RJ6 phone coupler ends with butyl tape and rescue tape to seal it from moisture.

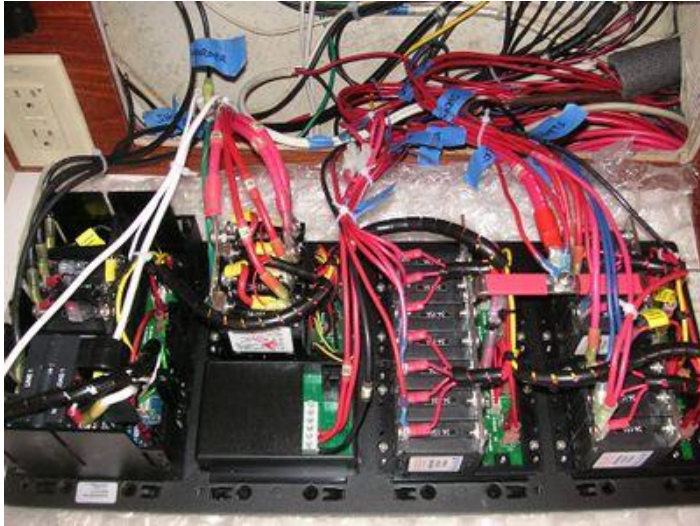
In photos (48) and (49), more breakers means more wires connecting to the main panel, but the organization of the wiring has been improved from the original.

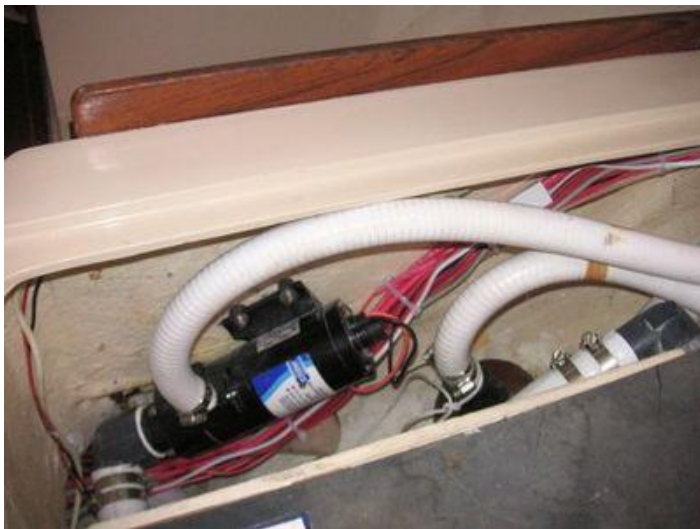
Here in photo (50) you see the wire bundle going by the macerator pump and motor up to the main distribution panel higher than before to get them off the hull and out of the way.

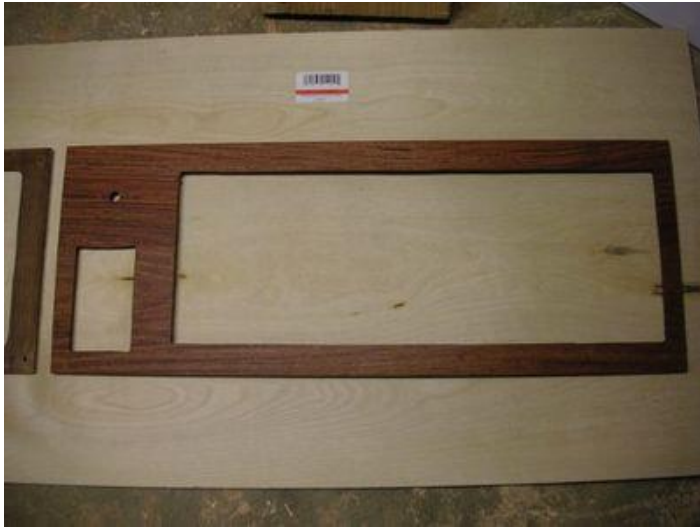
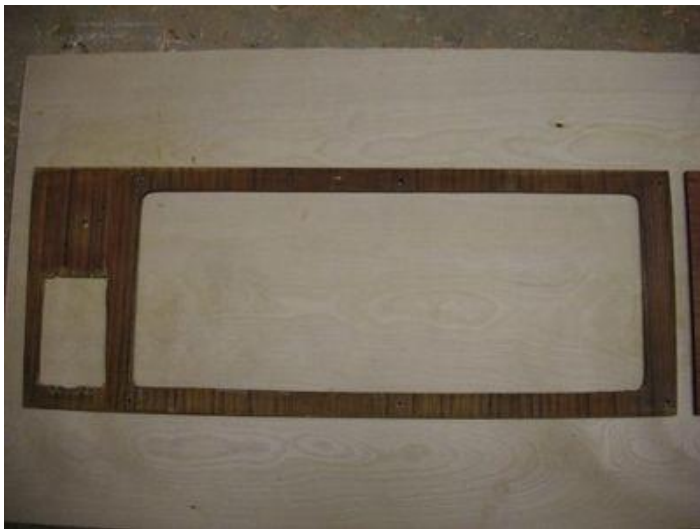
I also replaced the old 1/4" teak plywood with a new piece of solid teak 5/16" thick. The new teak is shown in photo (51) and the old is shown in photo (52). The new teak improvement is more dramatic in person, and is seen a little better in photos (53) and (54). New is shown in photo (54).

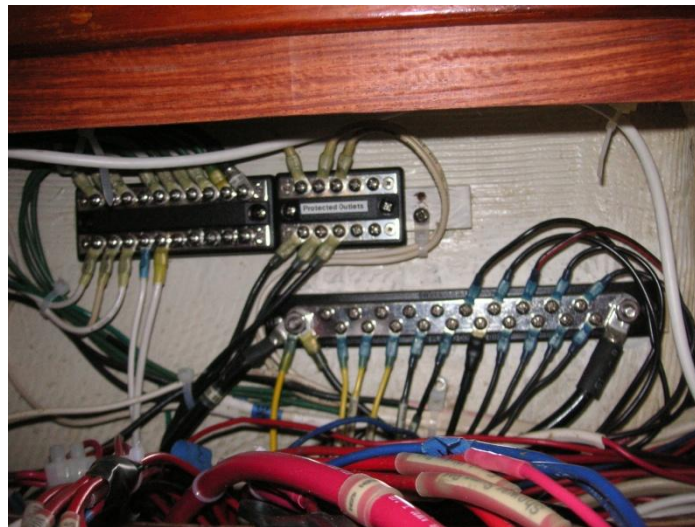
AC Busbar Replacement: I removed the original terminal strip in photo (53) and replaced it with a 10 screw dual busbar and a 5 screw dual busbar as shown in photo (54). In photo (53) you can see dark spots under the screw at the end of each wire. Those are corroded spade fittings with open crimps at both ends. I removed and replaced all with heat shrink adhesive lined ring terminals. They are now all nice and shiny new in photo (54). The 10 screw dual busbar is for most AC neutrals and all grounds. The smaller 5 screw dual busbar is dedicated to line and neutrals for the cabin, galley, and head protected AC outlets. The AC outlet power leaves the panel breaker and connects to the GFCI outlet at the Navigation Station. From there it connects to the 5 screw dual busbar for the downstream AC outlets, and is labeled "Protected Outlets". In this arrangement the cabin, galley, and head outlets are all protected by the Navigation Station GFCI outlet. The down side to this arrangement is the AC outlets are limited to a combined total of 30A. This may or may not be a nuisance item. I plan to wait and see if it is an issue before changing anything.

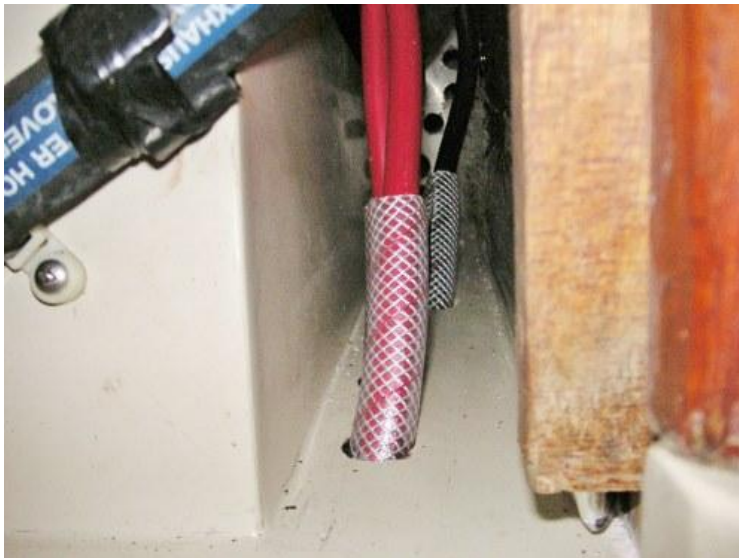
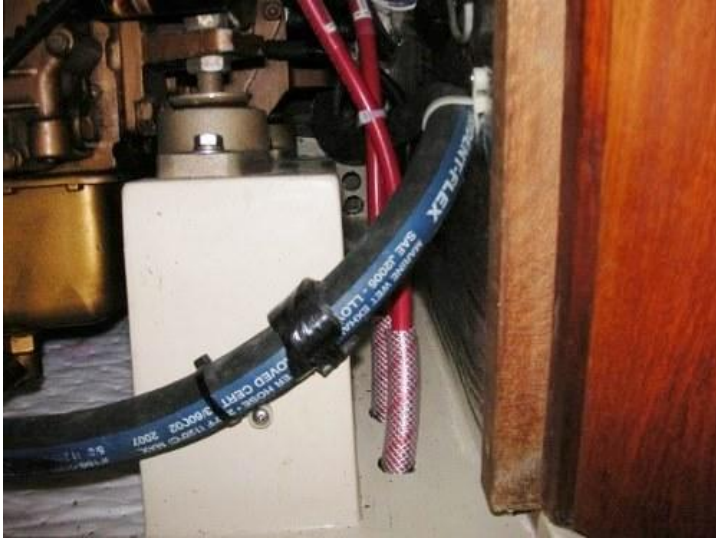
For the primary battery and charging circuit cables I used 1 AWG. There was a lot of discussion on what is the proper cable size to use on the Message Board. Refer to my post [1987 MK1 Electrical System Upgrade – Feedback Requested](#). The following photos (55) and (56) show how the starter, alternator output, and main negative (from the house negative busbar) cables run under the floor between the galley sink and enter the engine compartment where the hot and cold water hoses to the head used to be. I drilled a third 1” hole aft of the first two for the main negative to pass through. I was able to re-route the hot and cold water hoses directly to the head sink. There was just enough room for the two hoses to slide between the shower drain and the manual bilge pump hose. This is a shorter hose run to the head sink than the original route, which went from the galley sink area through the engine compartment, around the aqua lift muffler then back and up to the head sink. I used some of the extra ½” hose for chafe protection where the cables pass through the engine compartment floor.

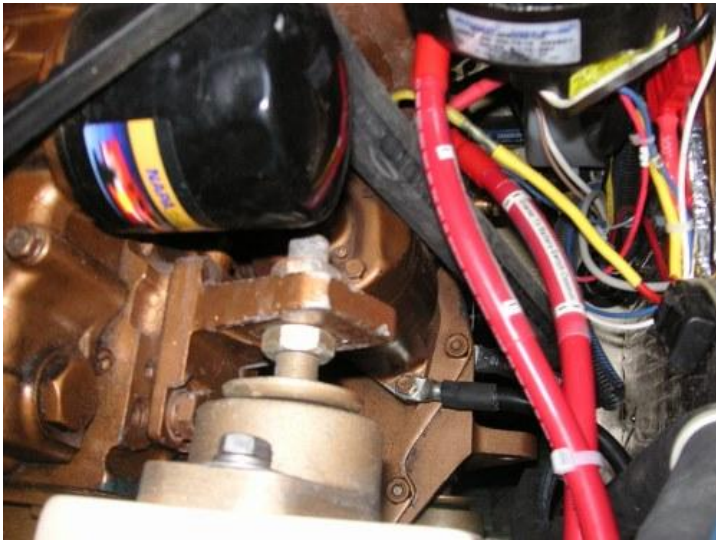
Photo (57) shows another view of the same three cables rising up to the alternator, starter, and main negative cable #14 connection on the starter motor mounting bolt.

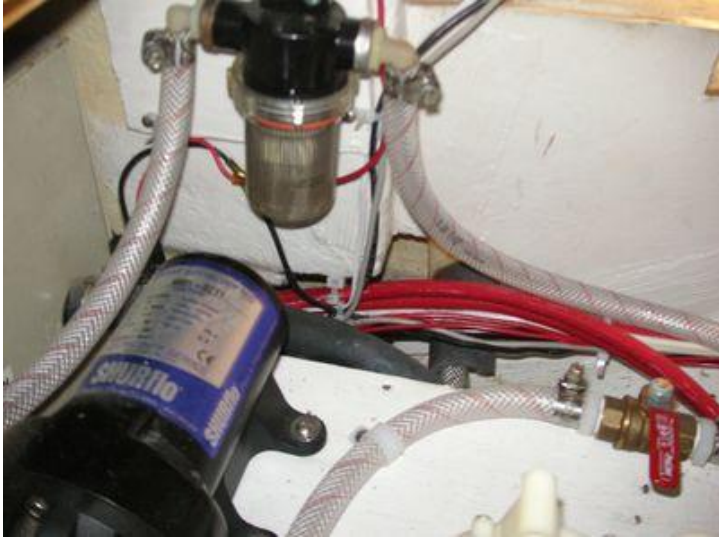
In photo (58) you can see I added insulation foam for 3/4" pipe on the water tank hose and band clamp to protect the cables and wires from chafing.

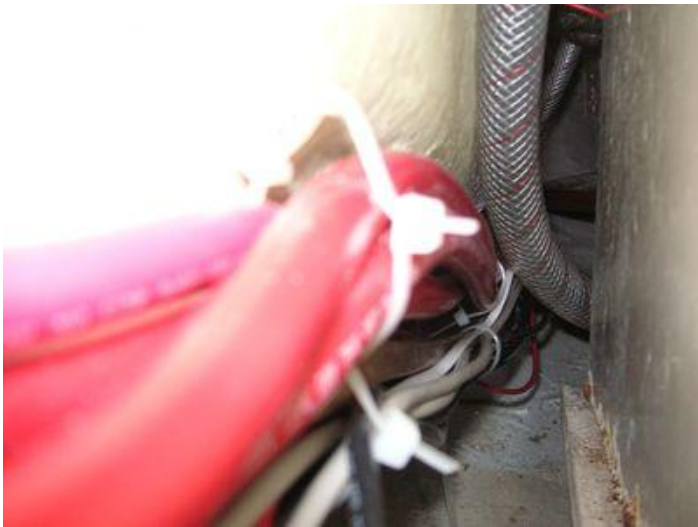
Photo (59) shows cables running between the water heater and the outside of the battery box. The wire tie mounts are attached to the thru holes I drilled in the battery box in the beginning. No other way to get in there and drill a hole. Photo (60) shows another use of the insulation material to cover the corner of the water heater support and shelf to avoid any cable or wire chafe. The insulation is attached to the heater shelf with a #8 SST screw fastened to the wood shelf so it doesn't move and leave the wires/cables exposed to the corner.

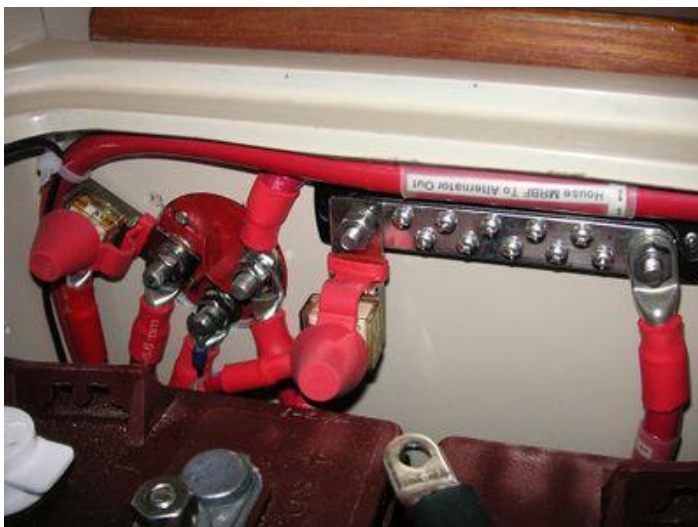
Battery Box Busbar: Photos (62) and (63) are looking inboard from the water tank to see inside the battery box. Photo (62) shows the primary cables inside the battery box connecting to the back of the 1-2-Both battery use switch. Position #1 (house bank) is on the right, Position #2 (reserve battery) is on the bottom, and Position C is on the left. The MRBF fuses (covered with the red caps) for the main distribution panel supply connecting to the C post, the AC battery charger, and power for the bilge pump breaker connecting to the “always on” busbar can also be seen. Photo (64) shows the alternator output cable running above the “always on” busbar. The protective cover is removed from the “always on” busbar for clarity. The alternator output cable is labeled upside down so it can be read from above when standing on the boat centerline looking down into the battery box. You can also see the jumper connecting position #1 of the 1-2-Both battery use switch to the “always on” busbar. The most critical DC item currently attached to the “always on” busbar are the bilge pumps. If the house battery bank were to fail, switching the 1-2-Both battery use switch to position #2 would not provide power to the always on busbar. To address this, I made the jumper long enough to be moved from position #1 to position #2 of the 1-2-Both battery use switch to provide temporary power. This failure mode is a remote possibility, but it could occur so I added this no cost redundancy feature.

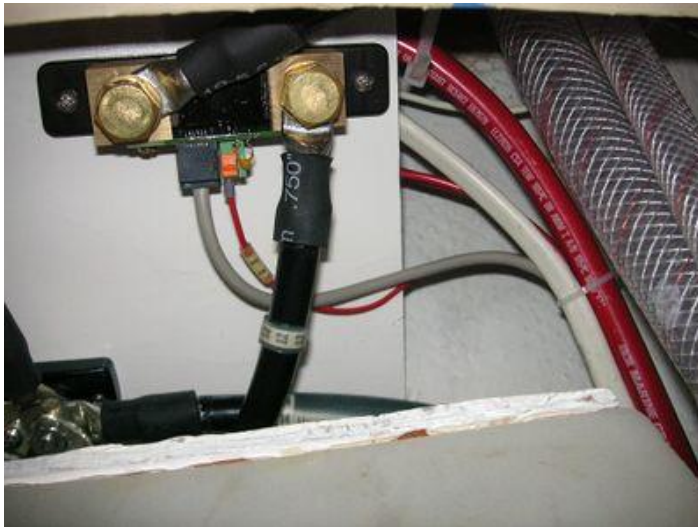
(67)

That same cable then connects to the left bolt on the BMV-700 shunt attached to the breadboard as shown in photo (67).

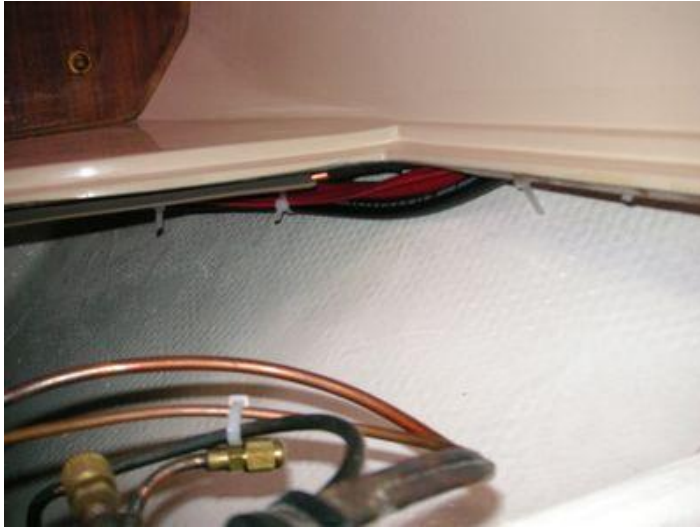
Photo (68) shows the positive and negative cables running to the reserve battery from the Digital Echo Charge, the SmartGauge, the 1-2-Both battery selector switch position #2, and from the house bank negative busbar. The shiny bit you see is the refrigeration line. To protect the refrigeration lines in case there is a gas leak from the maintenance free battery, I covered it with the material used to cover wires on the floor so you don't trip. Photo (69) shows the wires and cables from the reserve battery, Digital Echo Charge, and the SmartGauge running underneath the storage cubby holes behind the outboard salon seat cushion. The white Nomex is the existing DC wiring for the refrigerator compressor and fan. The wood you see is glassed in and is part of the boat. It wasn't added by me for this project.

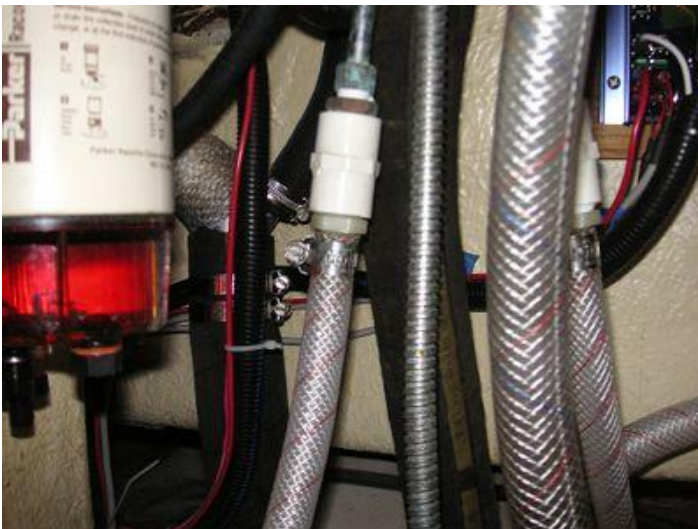
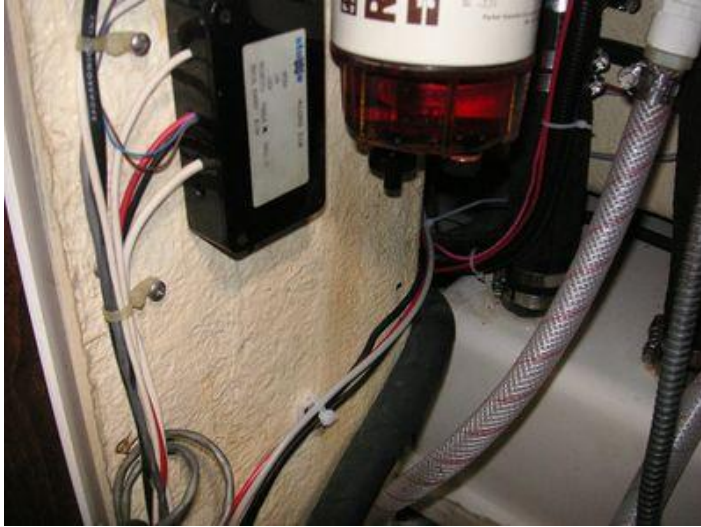
Photos (71) and (72) show the external regulator wiring under the head sink in the split loom, then is runs along the engine compartment bulkhead under the Racor filter.

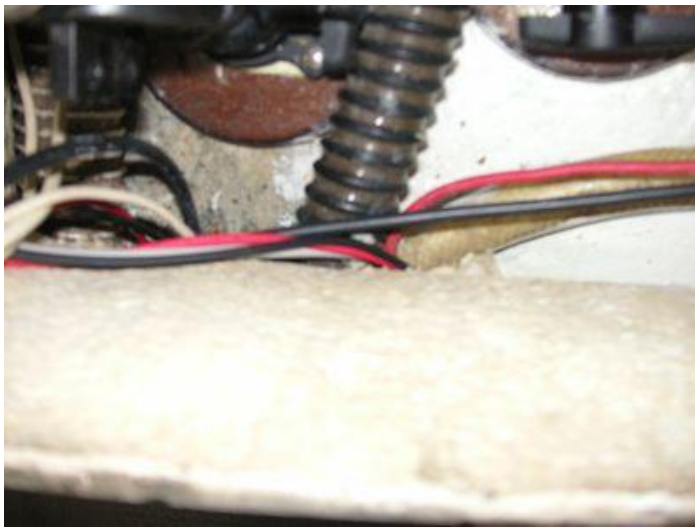
Photo (73) the external regulator wires enter the 3/4" conduit under the shower pan. They exit the conduit by the macerator pump/motor in photo (75) of the next photo group. The black box by the Racor is part of my non-working depth/temp/speed system.

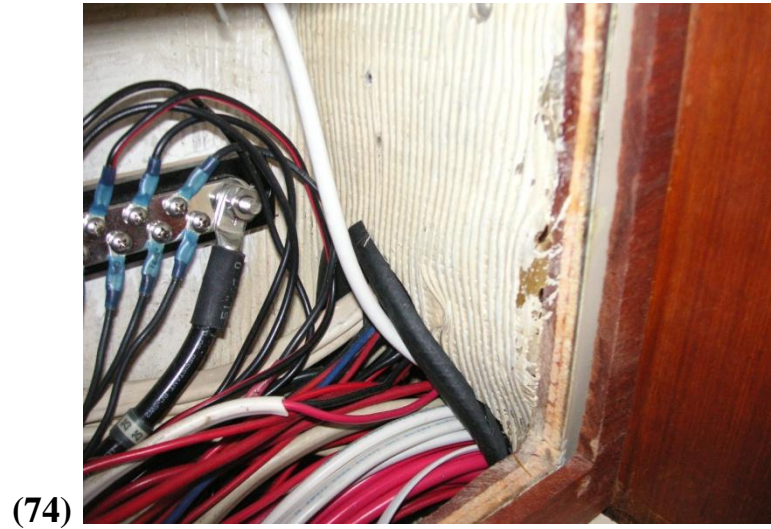
Finally photos of the wires running from behind the Main Distribution Panel, to the battery box area. Photo (74) shows the bundle exiting from behind the Main Distribution Panel with a chafe guard I made from some extra fuel hose, and photo (75) shows where they pass under the macerator pump/motor and pick up the external regulator wires.
